INDOOR AIR QUALITY ASSESSMENT

**Committee for Public Counsel Services
1 Congress St, Suite 102
Boston, MA 02114**

Prepared by:
Massachusetts Department of Public Health
Bureau of Environmental Health
Indoor Air Quality Program
January 2017

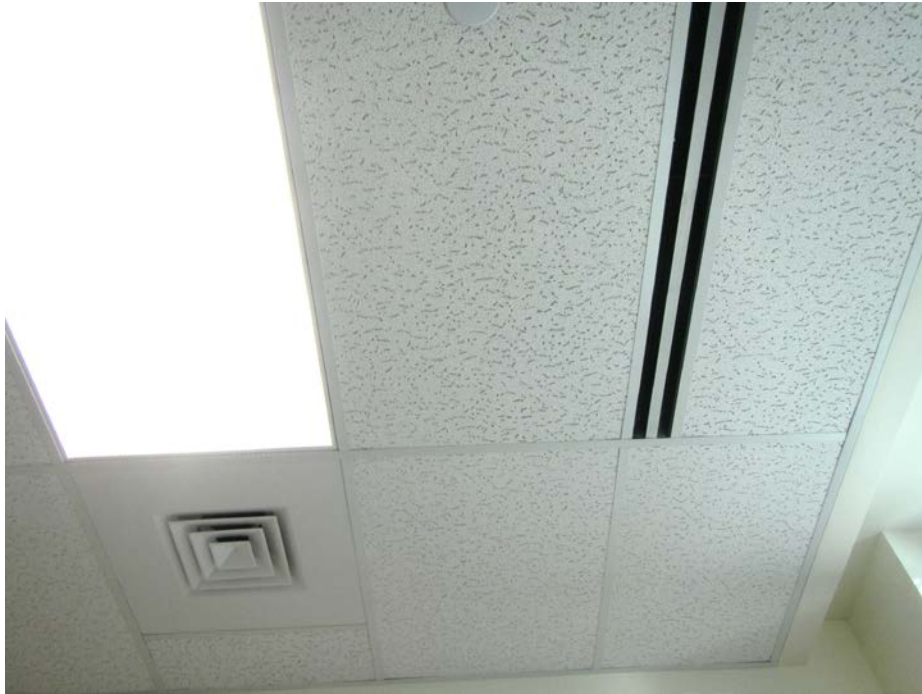
Picture 1

Heating, ventilation and air conditioning (HVAC) are provided by rooftop air-handling units (AHUs) ducted to supply and return vents. Conditioned air is delivered to occupied areas via louvered supply vents (Picture 1), and the air is returned to the AHUs via exhaust vents (Picture 2). It should be noted that some return vents had louvered supply diffusers (Picture 3), which can hinder the draw of return air. At the time of assessment, the HVAC system was operating. The AHUs are monitored by an energy management system. It should be noted that one of the energy management controls was on the air conditioning setting. AHU controls should be operating to in a manner that ensures continuous air filtration and circulation throughout the space. Lack of air exchange/circulation can lead to the build-up of naturally occurring pollutants in the space, which can result in IAQ/comfort complaints.

Supply vents

1. Operate supply and exhaust ventilation continuously in all areas during occupied periods. Ensure all HVAC equipment is maintained and supply and return vents are cleaned periodically to prevent dust re-aerosolization.

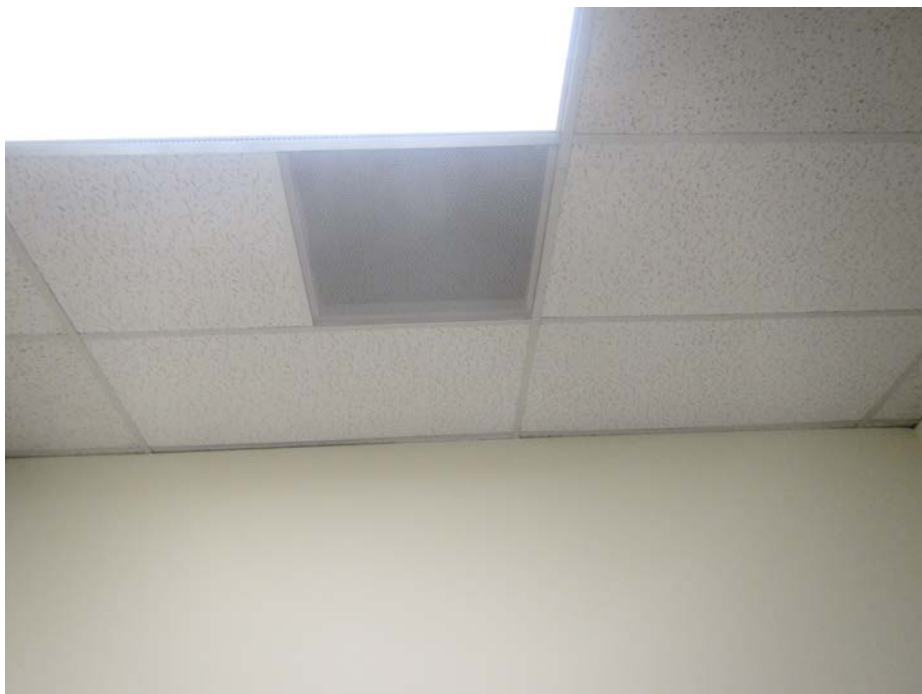
Picture 2

Return vent

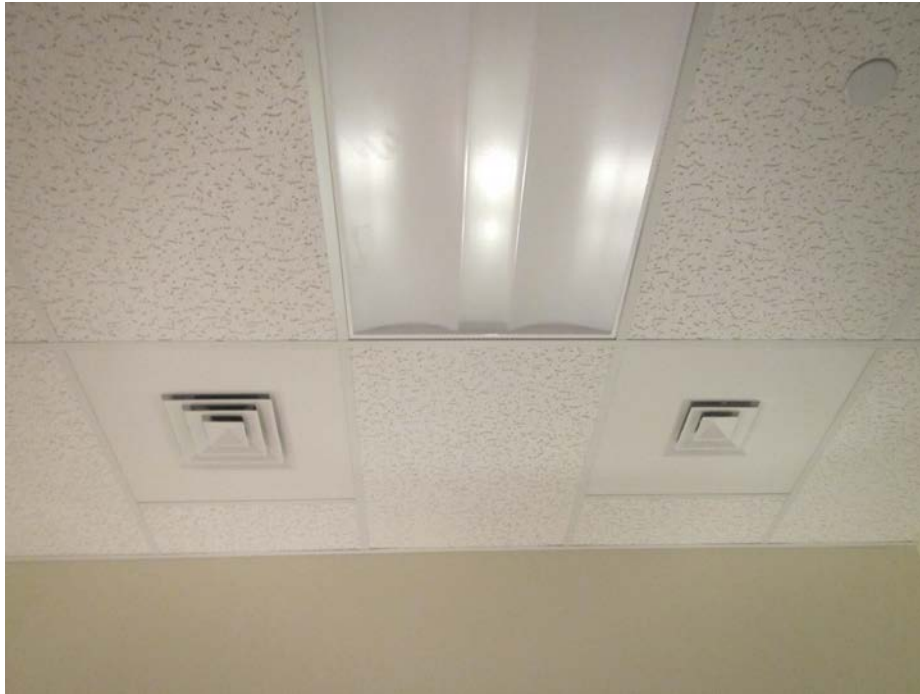
Picture 3

Supply louver on return vent

2. Ensure energy management systems are set to the appropriate settings.
3. Consider replacing return vents with louvers with non-louvered vents.
4. Adjust directional blades for air diffusers along the window to a 45-degree angle.

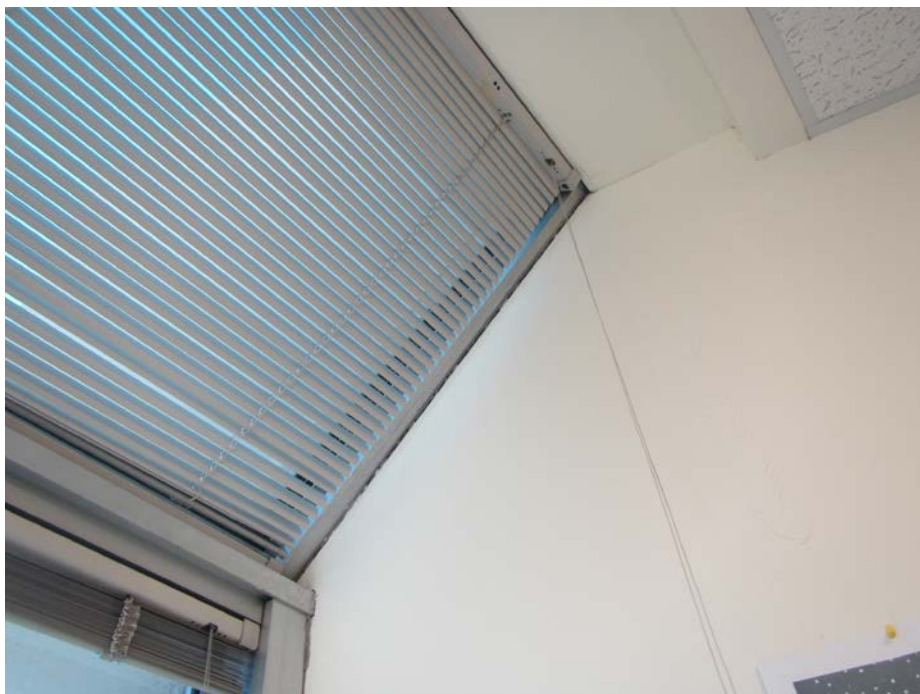
Picture 4

Breaches due to failing caulking were observed around windows (Picture 4). Measures should be taken to ensure windows are sealed to prevent moisture from entering the building. Breaches also increase air movement from the outdoors and may provide a pathway for pests.

Damaged/failing caulking around window system

7. Keep plants in good condition, avoid overwatering, and remove from the airstream of heating and ventilation equipment.
8. Repair seals around windows to prevent moisture and drafts into the building.

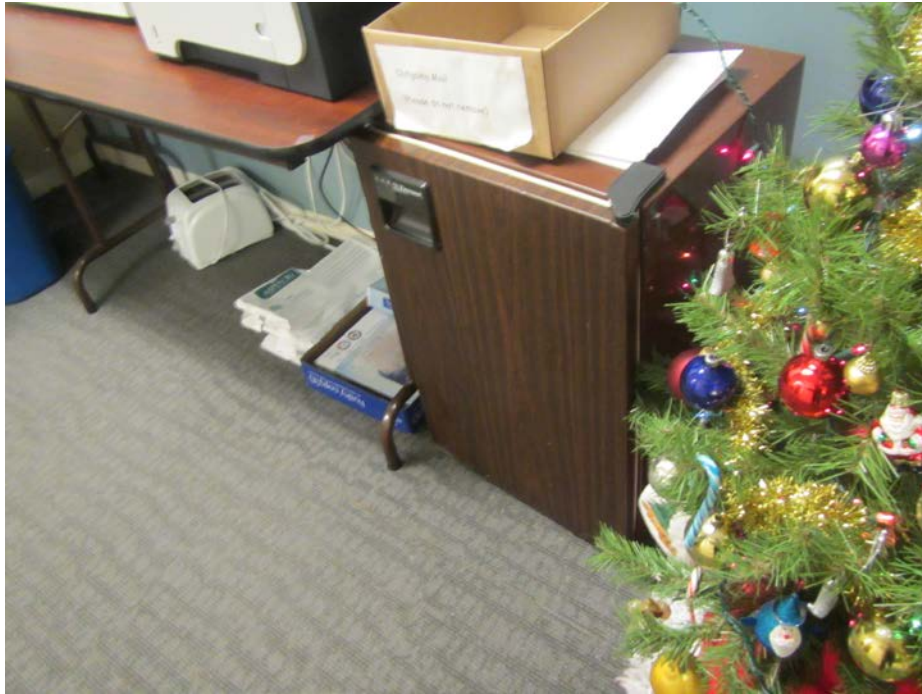
Picture 5

Small refrigerators and water bubblers were directly on carpet (Picture 5). Leaks from these appliances can damage carpeting. Plastic or rubber mats with raised edges should be placed under these items to catch water from spills or leaks.

Small refrigerator on carpet

9. Place plastic or rubber mats below refrigerators and water dispensers to catch water.
10. Reduce the use of cleaning products, sanitizers, and other items that contain VOCs. Eliminate the use of scented candles and other air freshening products.

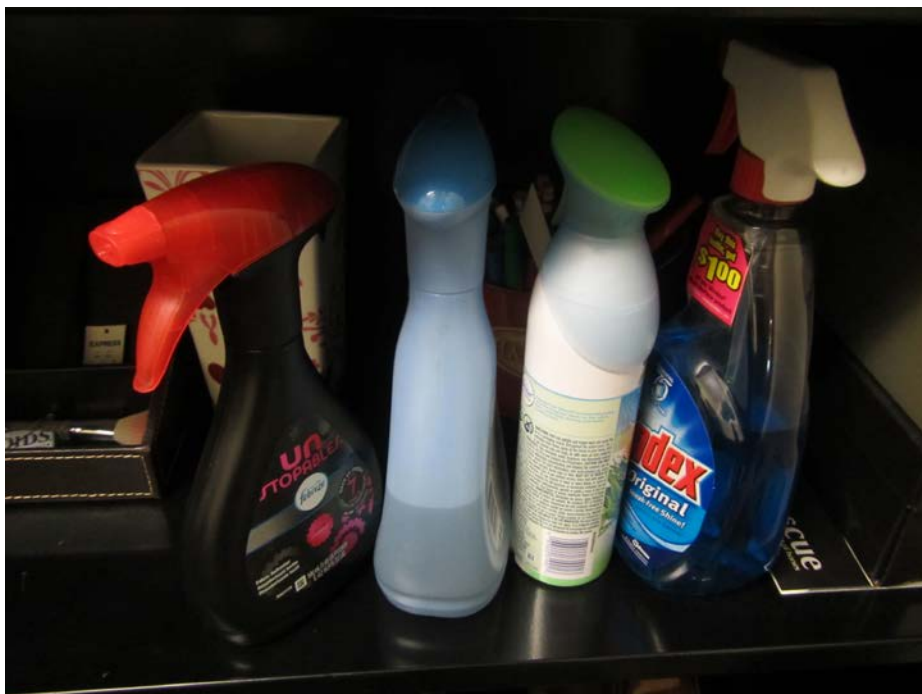
Picture 6

Exposure to low levels of TVOCs may produce eye, nose, throat, and/or respiratory irritation in some sensitive individuals. In addition to testing, BEH/IAQ staff examined spaces for products containing VOCs. BEH/IAQ staff noted air fresheners, deodorizers, candles, hand sanitizers, cleaning products, compressed air canister, and dry erase materials in a number of areas throughout the office space (Table 1; Picture 6). All of these products have the potential to be irritants to the eyes, nose, throat, and respiratory system of sensitive individuals.

Cleaning products and air deodorizers

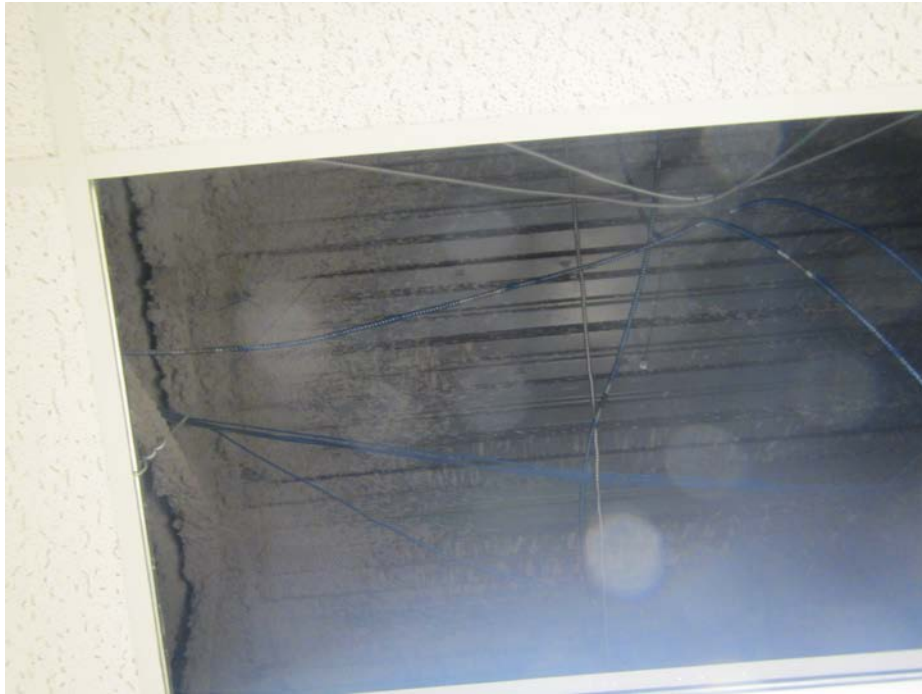
Picture 7

Missing ceiling tiles were observed in some areas (Table 1; Picture 7). Missing and ajar tiles can allow dust and debris in the plenum system to migrate into occupied areas. Care should be taken to ensure all the ceiling tile system is complete and ceiling tiles are flush.

Missing ceiling tile, note dust/debris in plenum space

12. Clean blades of personal fans to prevent aerosolization of dust.
13. Reduce the amount of items stored on flat surfaces to allow regular cleaning.
14. Ensure all ceiling tiles are intact and installed flush in the ceiling tile system. Missing tiles should be replaced to prevent movement of dust and debris from plenum into occupied areas.

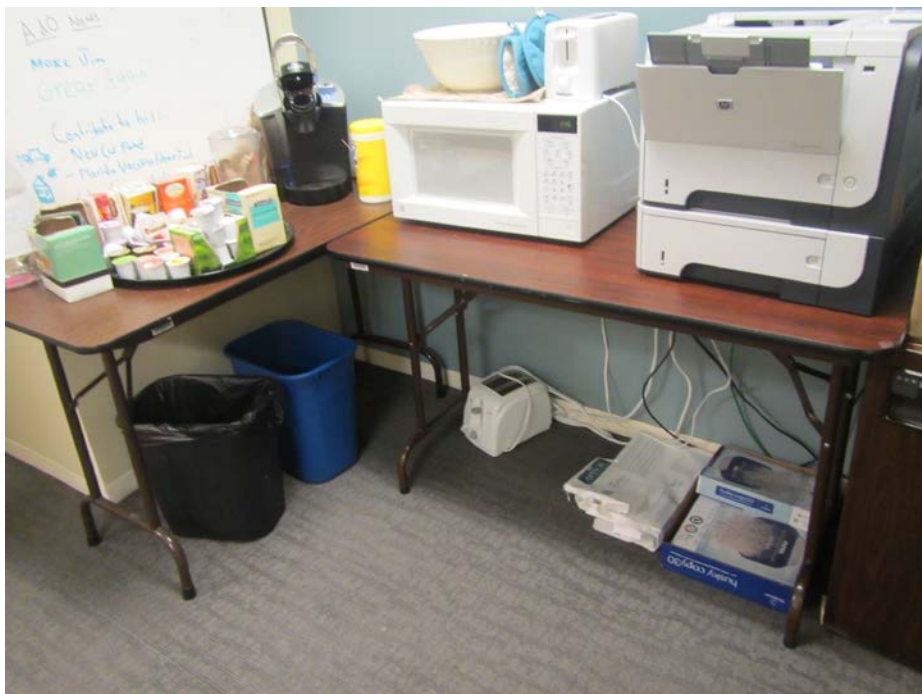
Picture 8

Small food appliances and food items were observed in a common area (Picture 8). These items can attract pests. Food should be stored in air-tight containers, and appliances should be cleaned periodically to prevent pest infestation.

Food appliances and food in common area

15. Ensure food appliances such as toasters are cleaned regularly to prevent pests. Food should also be stored appropriately.
16. Ensure space heaters are not left unattended.
